Investigation Report

Address: A Government ITS Center Reported by: Schneider and Fengsheng Electric Pte Ltd (also known as "FS") Date: 26th January 2017 Subject: Air Circuit Breaker Analysis

Equipment Ref : Low-voltage Air Circuit Breaker **Model :** NW25H1 with neutral left pole **Switchroom Ref :** Generator Room (Generator Control panel) **Serial Number :** 2130085611-1

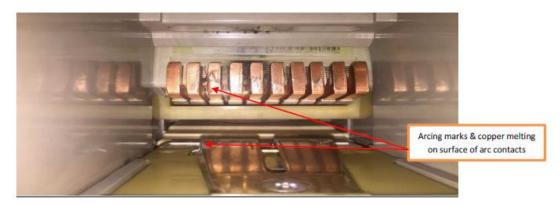
o Upon opening the arc chutes, we observed burnt mark on phase 1 and phase 3 of arc contacts.

o Based on the investigation conducted by Schneider Electric, there are possible few scenarios whereby the breaker arc contacts will have the same outcome example like a circuit breaker sudden opening due to a high fault current and also when opening / switching off breaker at avery high load.

o Schneider proceeded to clean and polish the arc contacts on all the phases and neutral pole.
